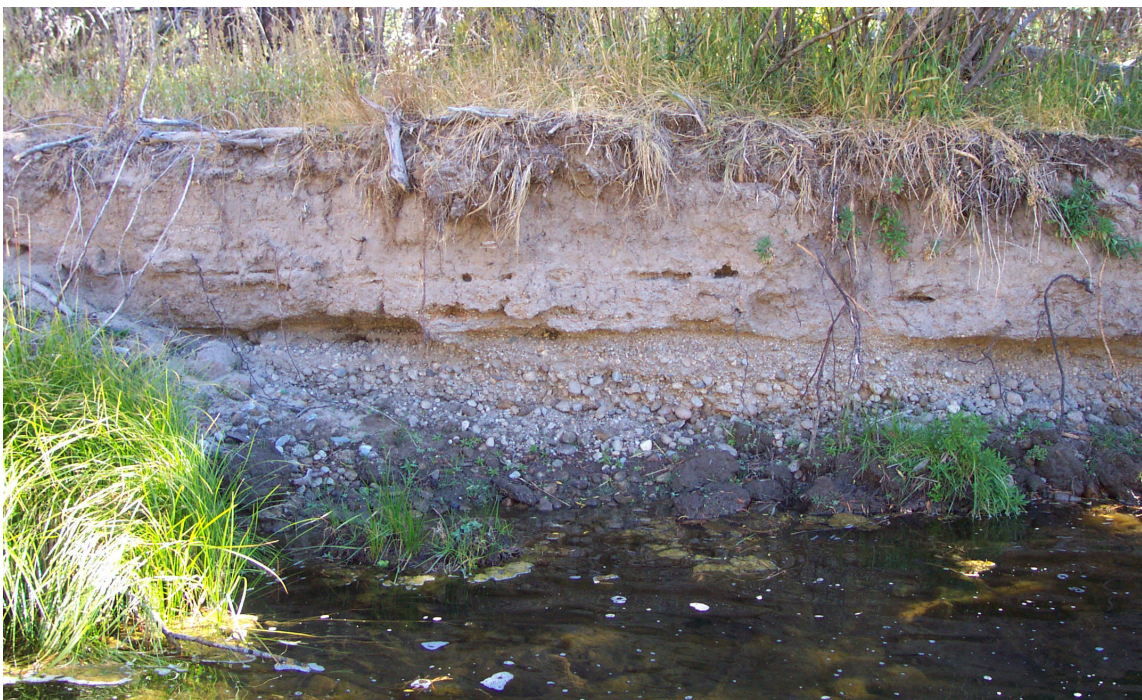
Figure 4-17. Typical bank rated “moderate” in fine-sediment contribution due to large portion of coarse material in the bank.
